Miscellaneous Paper SL-95-5
December 1995

Evaluation of Concrete Seawalls at Perry's Victory and International Peace Memorial

by Roy L. Campbell, Sr., G. Sam Wong

Final report

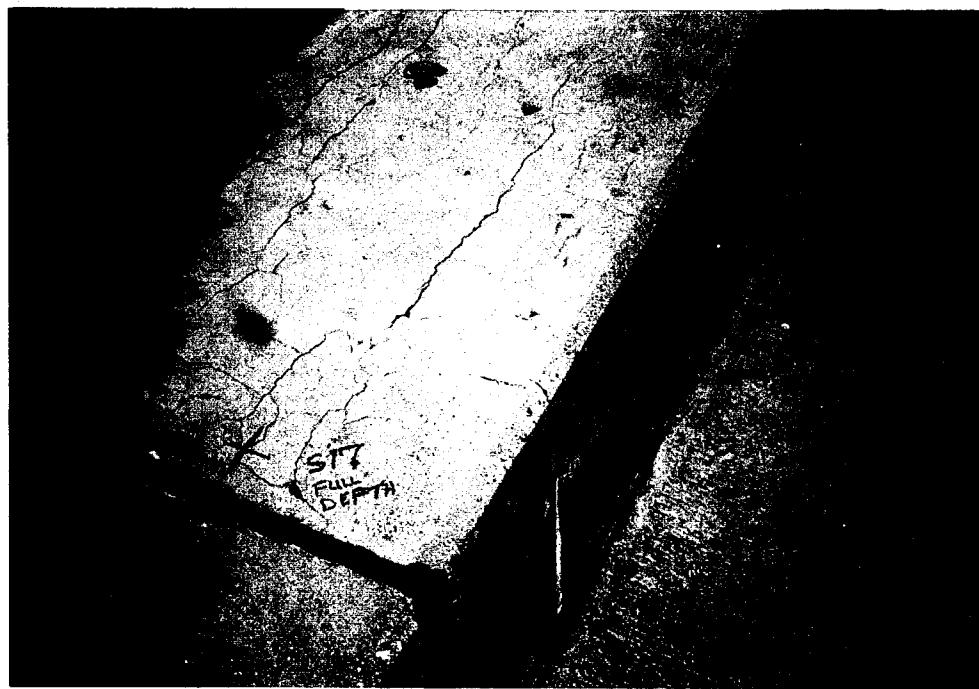
A visual inspection of the south seawall found that most of the distress and deterioration in the concrete was observed along the top-lakeside edges at the vertical joints (Figures 5 - 8). Extensive cracking was observed in the tops of four monoliths, S7, S16, S17, and S20 (Figures 9 - 14). Areas of reddish-brown stains were observed coming from cracking along a longitudinal plane in landside (Figures 10 and 11) and lakeside faces of these monoliths.

Figure 11. Cracks and stains in faces of south seawall monolith S17 at joint 17/18

Corrosion of the reinforcing steel was indicated in the four south seawall monoliths by areas of reddish-brown stains coming from cracking along a longitudinal plane in landside and lakeside faces. Reddish-brown stains were also observed coming from cracks in the concrete at the ladder recess of north seawall monolith N22.

There are forty locations in the south seawall where distressed and deteriorated concrete should be consider for removal and replacement (Table 7). Four locations (monoliths S7, S16, S17, and S20) include removal and replacement of the top 460 mm (18 in.) of the monolith and the other thirty-six locations are for repairs at a joint. In general, it is recommended that for repairs at a joint the concrete be removed and replace from the joint back approximately 610 mm (24 in.) and from the top down approximately 380 mm (15 in.).

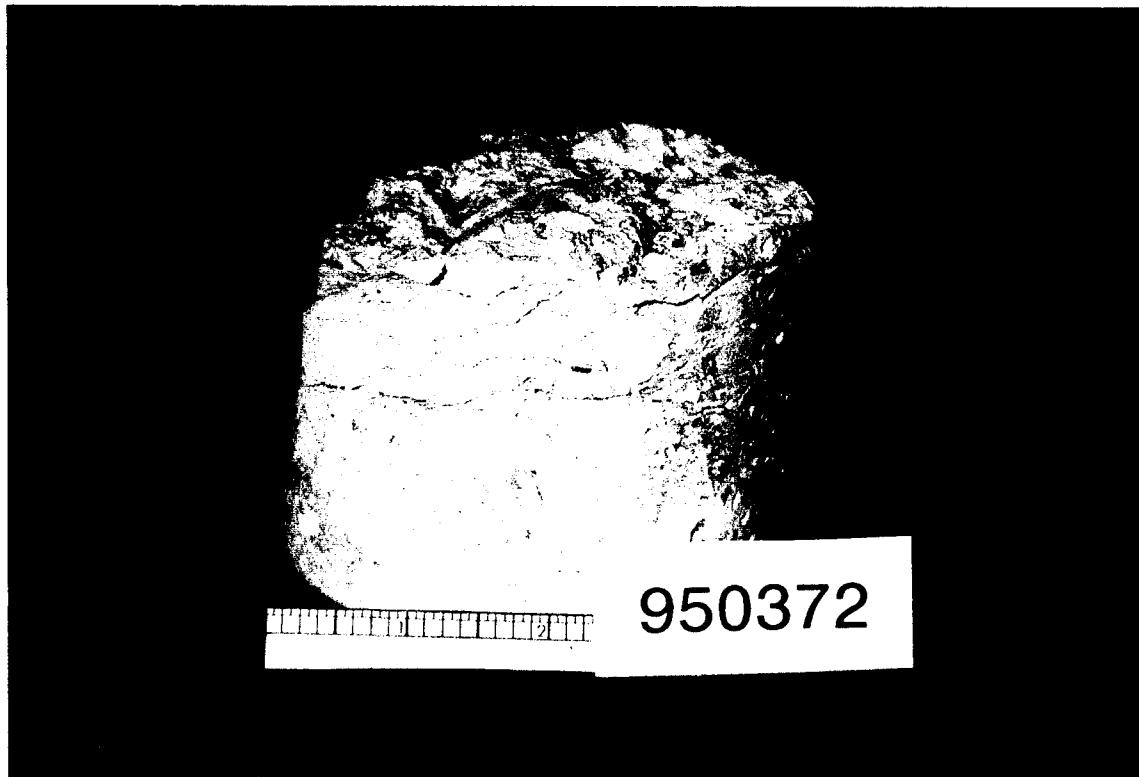
VI. Many of the fractures were parallel to subparallel cracks. Some tended to be subparallel to the surface of the structure. Examination of photographs show the cracks and fractures are at edges, corners, and near exposed surfaces. Some of the cores show incipient fractures with only a slight indication of crack propagation while others were open and others consisted of multiple cracks causing the concrete to be rubble.

Figure B-29. Cracking parallel to top surface of structure (bottom of photo) occurs several inches below surface and cannot be detected by visual examination

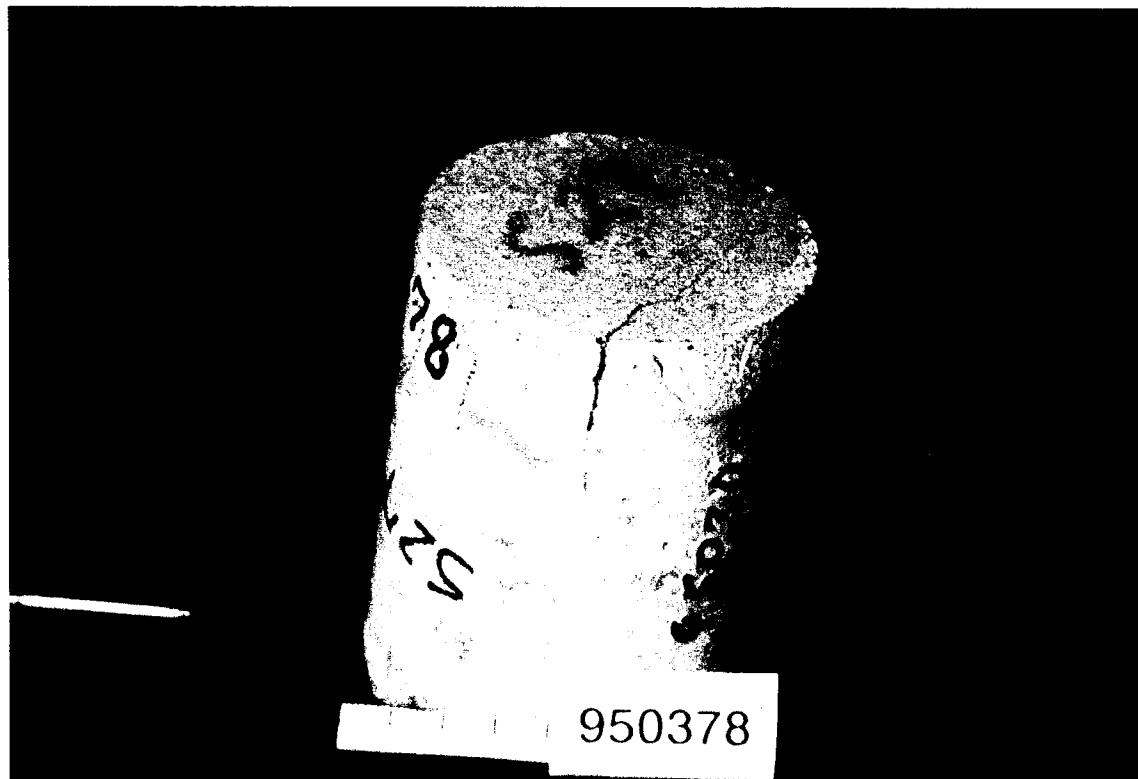
Figure B-30. Vertical crack in sample 950378 goes to the surface of the concrete
